Project Name: Best Buy Downers
Grove #301

Date: 12/26/2013

Building Information

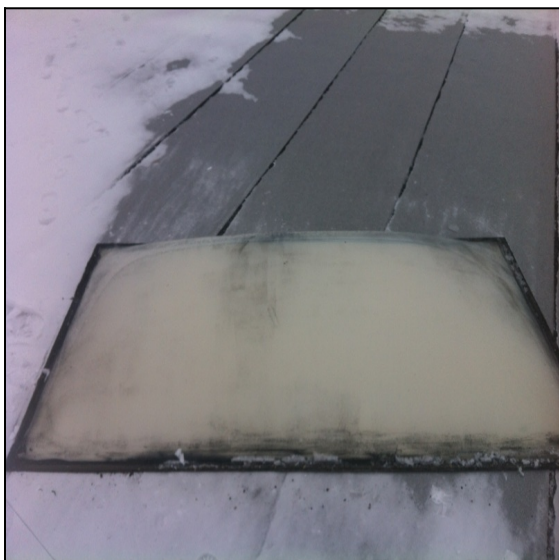
Item of Inspection: Old skylight lens that has failed.

Photo 1 Notes: Removed old skylight. all materials will be hoisted with Local Roofing crane, fall protection will be required at all times.

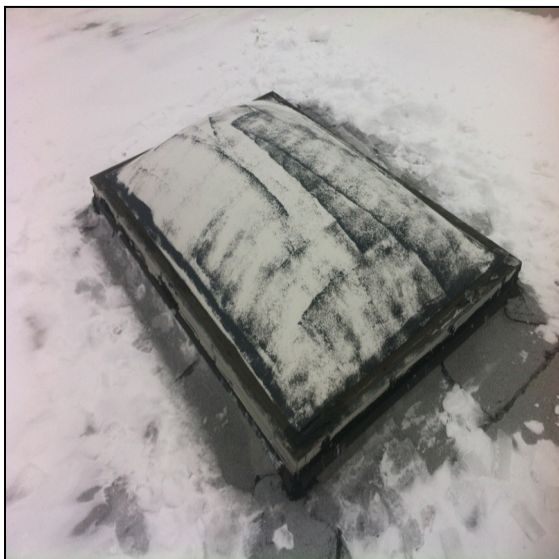
Item of Inspection: Old skylight lens.

Photo 1 Notes: Removed old skylight. (Two Total)

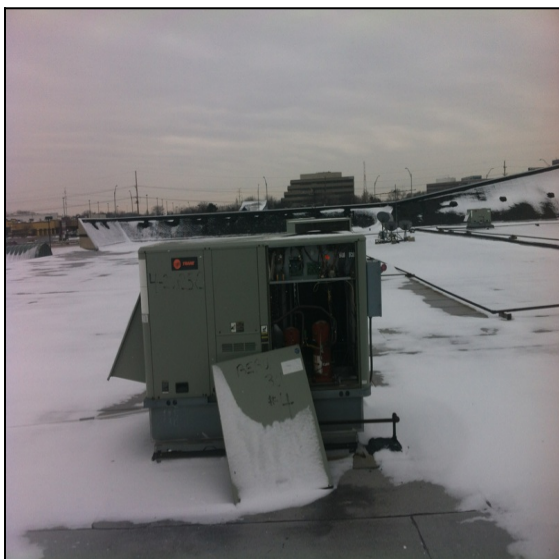
Photo 1 Notes: Due to severe winds Hvac unit door had blown off.

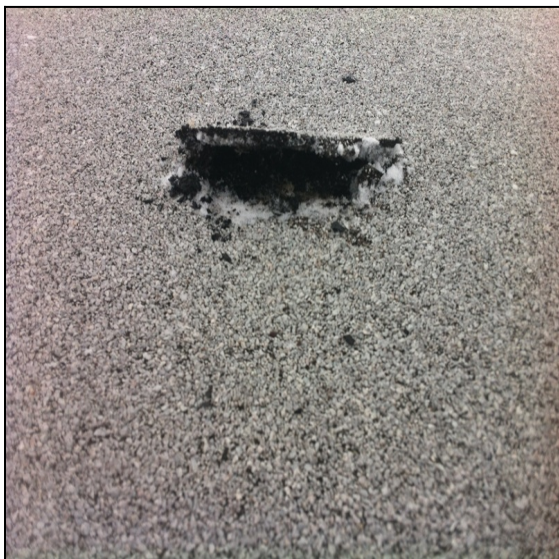
Item of Inspection: upon the install of the new skylight lenes; found a puncture in roof's membrane.

Photo 1 Notes: Found large puncture in roof's membrane. Removed snow, ice, and cleaned area.
