**Project Name:** Crossfit carbon. C/O  
 Arthur J Rogers.

**Date:** 01/16/2014

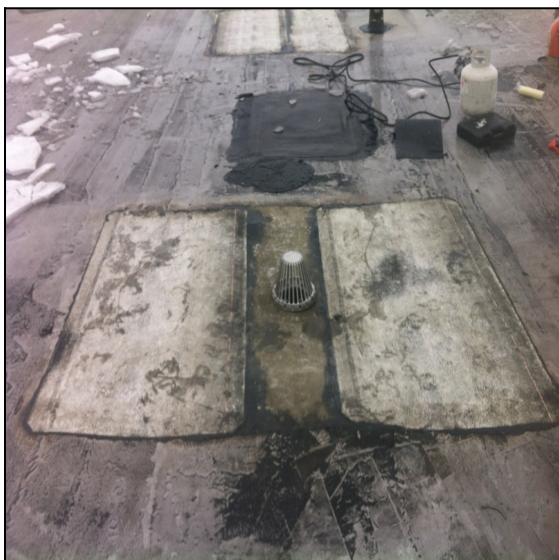
**Item of Inspection:** Leak location at drain.

**Photo 1 Notes:** Removed snow, ice, and Installed new 6" spun aluminum drain insert.

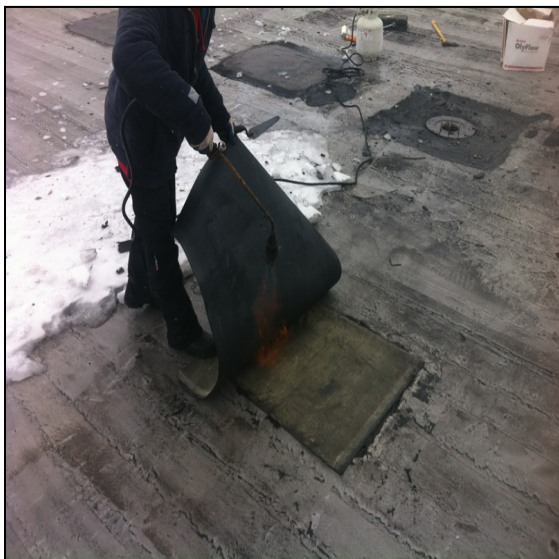
**Item of Inspection:** Removed existing 8" cone flashing.

**Photo 1 Notes:** Removed stack installed steel decking and new insulation to match existing height of roof system.

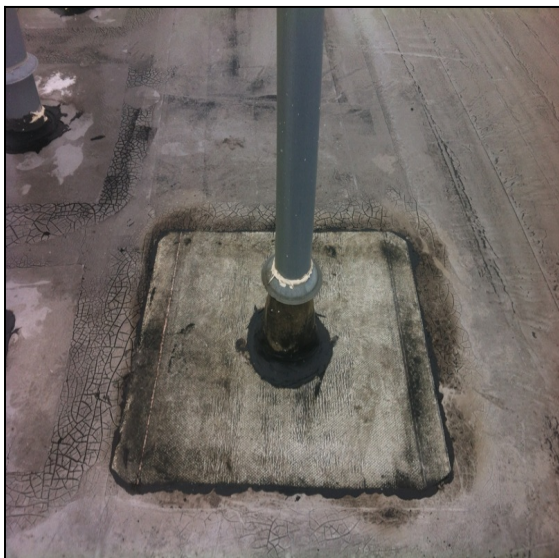
**Item of Inspection:** Re-flashed stack with APP smooth modified.

**Photo 1 Notes:** Installed new flashings up the vertical of the steel cone. ( Three total )

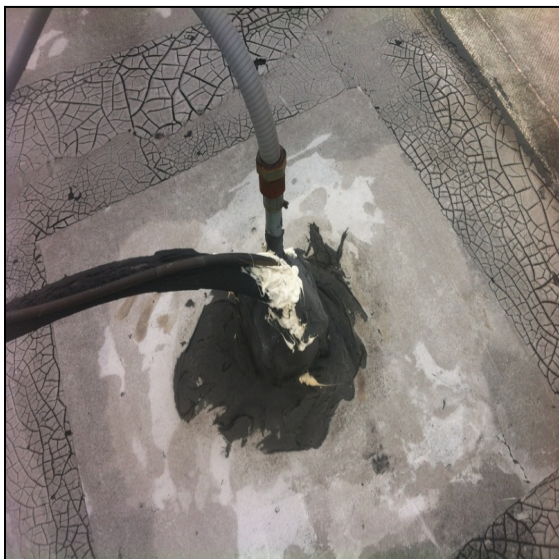
**Item of Inspection:** Failed Pitch pan detail.

**Photo 1 Notes:** The asphalt has dried up and cracked open.
